## **Demonstration and Validation of a Lightweight Composite Bridge Deck Technology as an Alternative to Reinforced Concrete**

Final Report on Project F09-AR16

August 2016

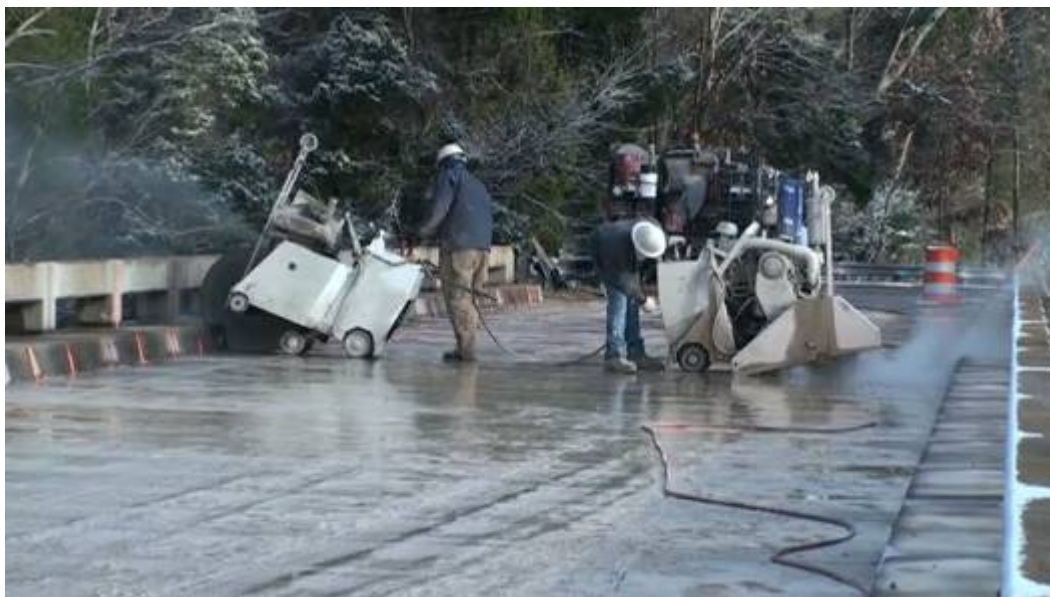
Figure 6. Cutting original bridge deck and barrier rail during demolition.

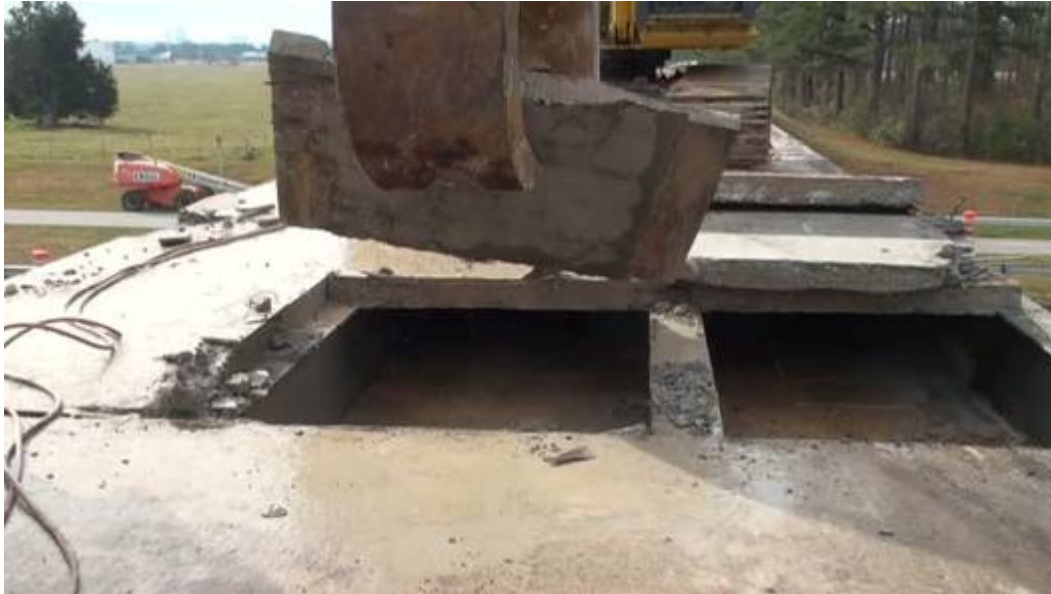
Figure 9. Removal of concrete deck section.

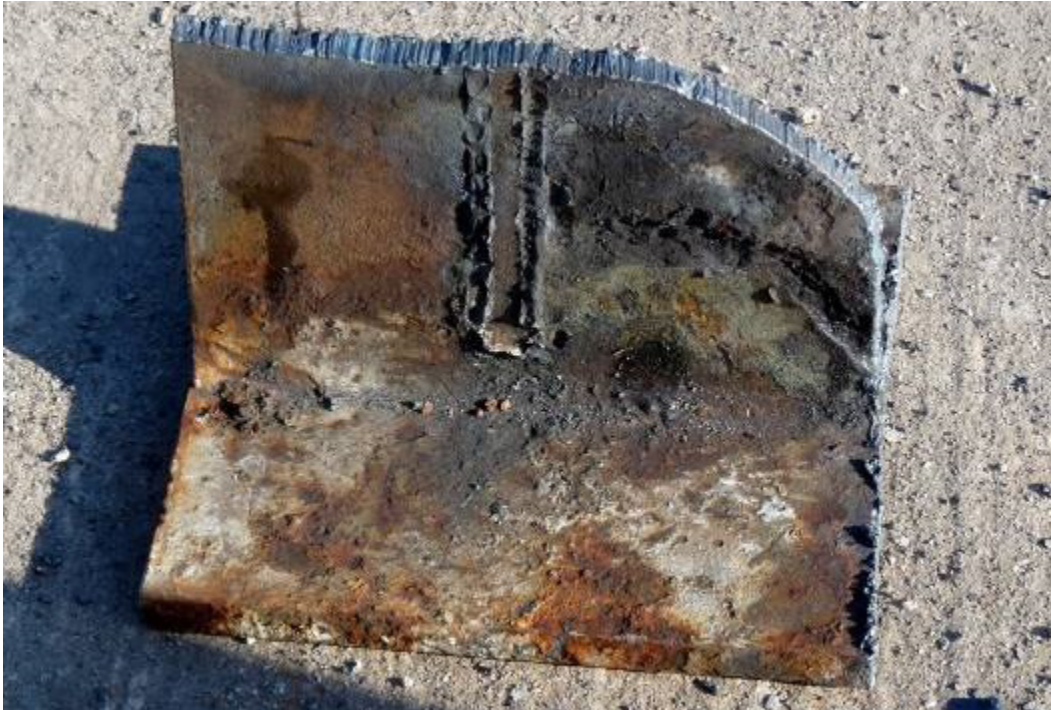
Next the girders were cleaned, inspected and rehabilitated. The inspection revealed that the upper corners of the girder ends needed to be replaced due to extensive corrosion. Figure 10 through Figure 12 show an end of a girder with the section removed, the extent of corrosion damage, and the repaired girder. Also the southeastern-most girder section was replaced in its entirety due to corrosion and impact damage. All girder refurbishment was performed by Redstone Arsenal DPW and was not part of the CPC project.

Figure 11. Removed section of girder shown in Figure 10.

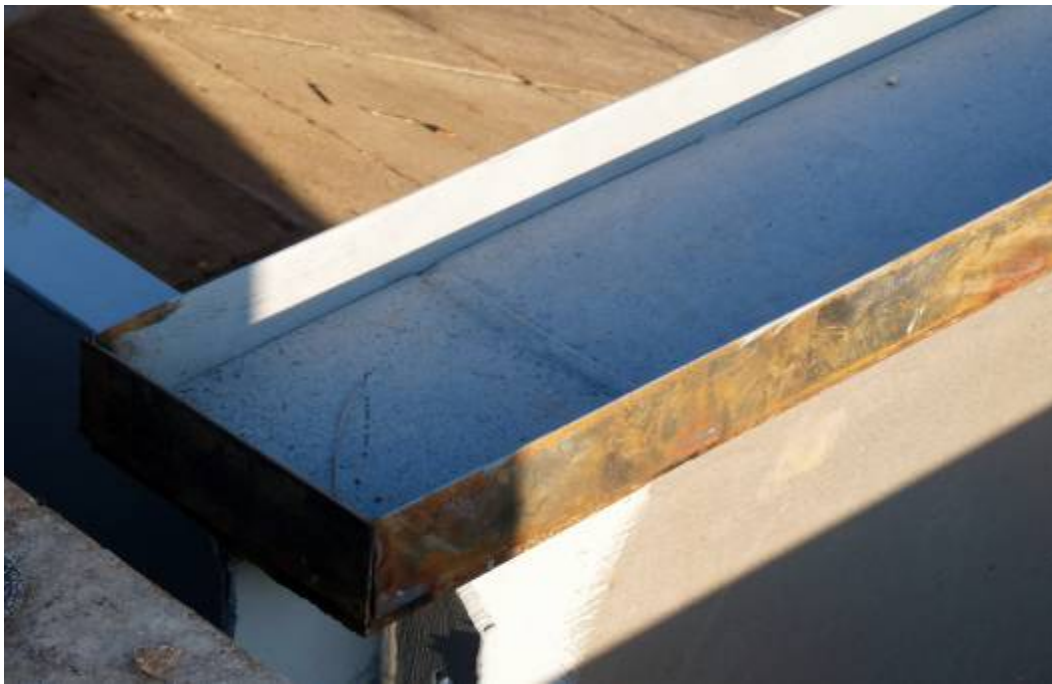
Figure 13. Form for grout haunch fabricated by tack welding steel strips to the top of the girder.

After the girders were refurbished or replaced, the forms for the grout haunch were installed. These were fabricated using 0.125 in. thick steel set upright and tack welded around the perimeter of the top surface of the girder to create a form to hold the liquid grout (Figure 13). (For this bridge, the grout haunch was a minimum thickness of 2.75 in. in order to clear rivets used in the girder connections.) After the grout form was constructed, the pultruded deck sections were placed directly on top of the welded grout form. The deck sections were placed by hand, progressively providing a work surface for transporting the new sections over the previously placed sections using a pallet jack (Figure 14). The deck is shown in Figure 15 with all pultruded sections in place.

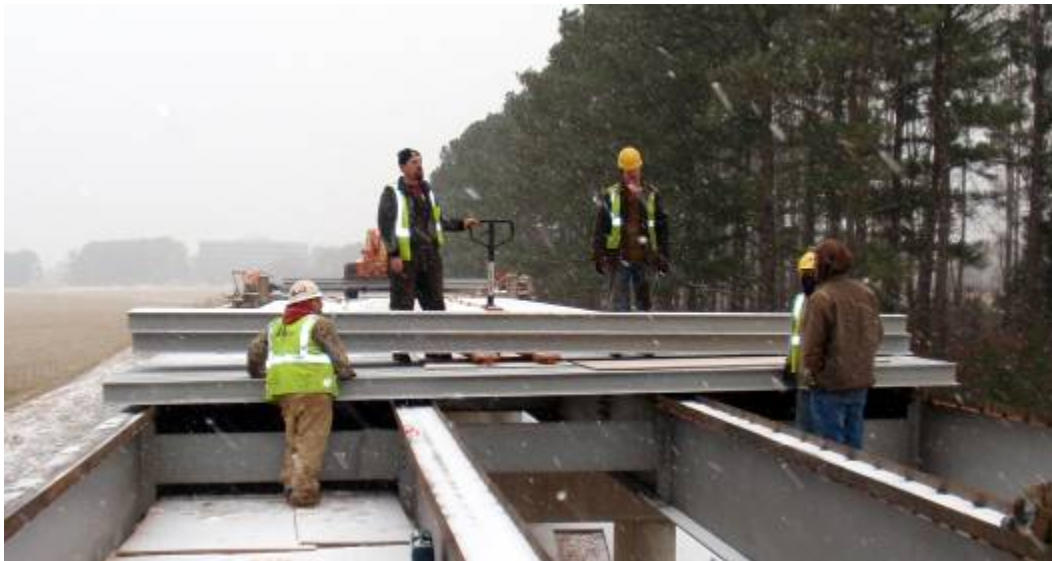
Figure 14. Placement of pultruded deck sections on top of the grout haunch form.

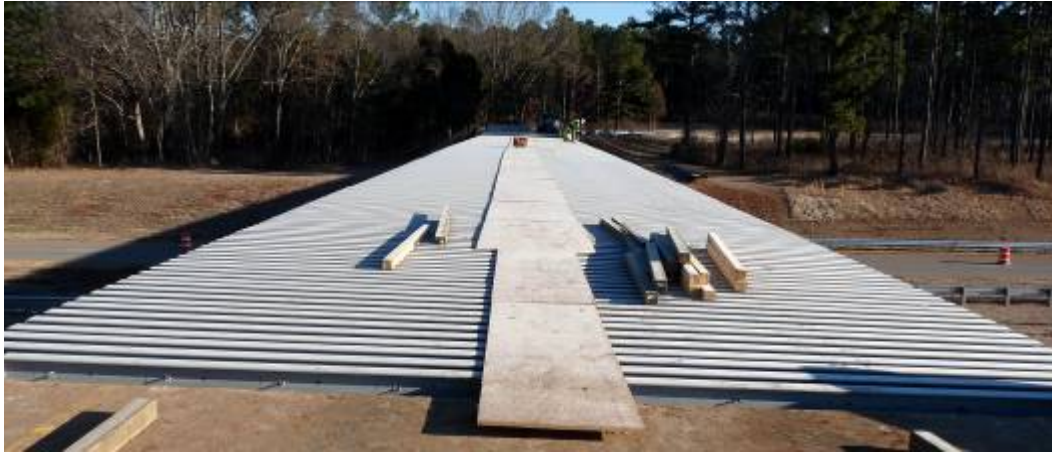
Figure 15. All pultruded deck sections in place over grout forms on girders.

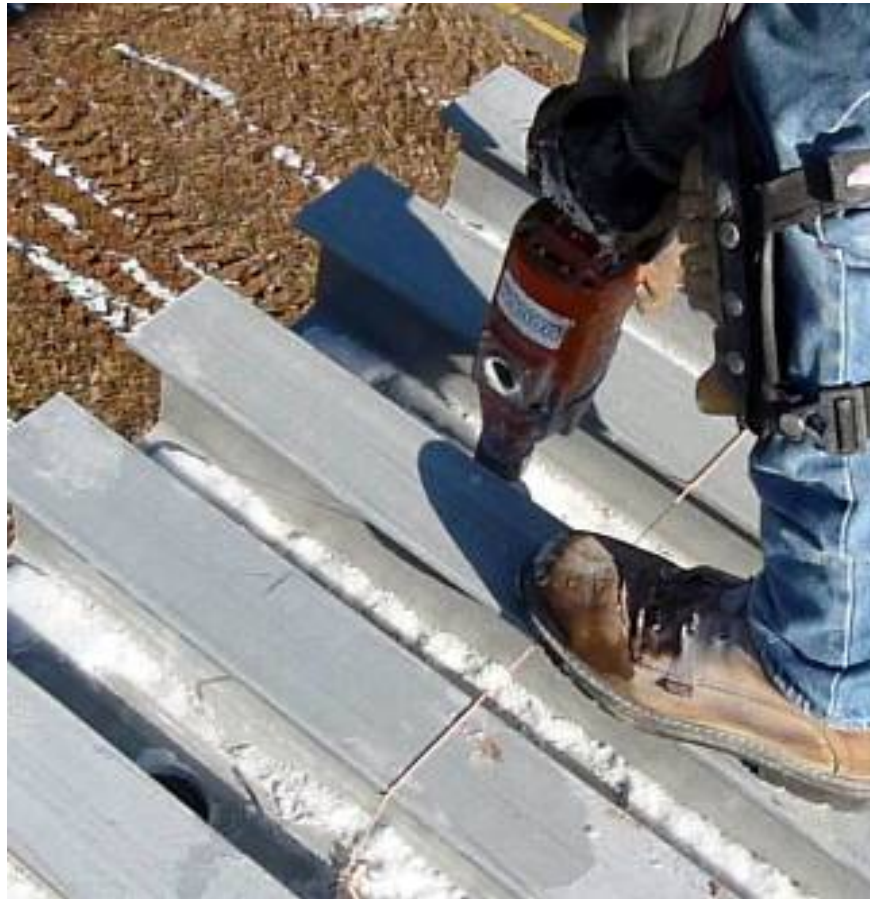
Figure 16. Drilling access hole in pultruded section.

Next, workers drilled 3 in. diameter holes (Figure 16) in each deck section to allow for welding the shear studs in place and to serve as grout-injection points. Typical access holes are shown in Figure 17. At this same time, the 0.5 in. weep holes were drilled into the deck sections.

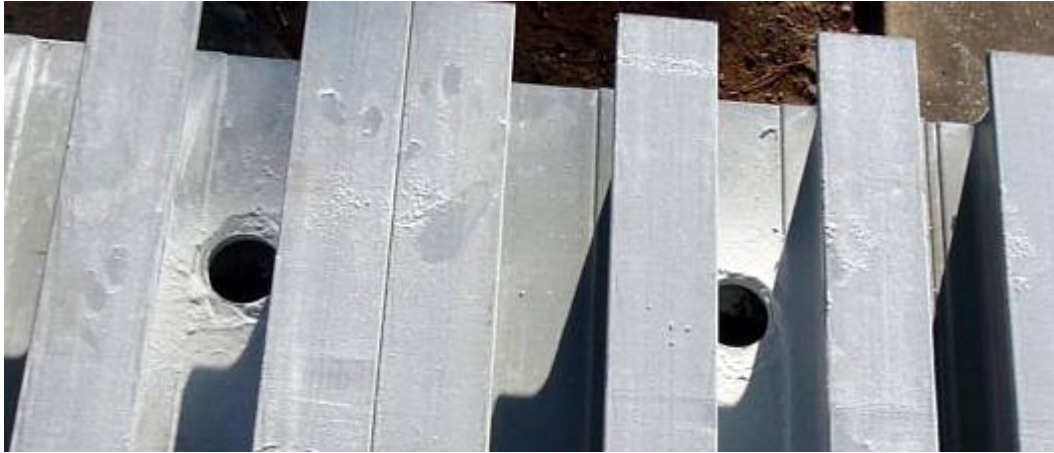
Figure 17. Drilled access holes shown before stud installation.

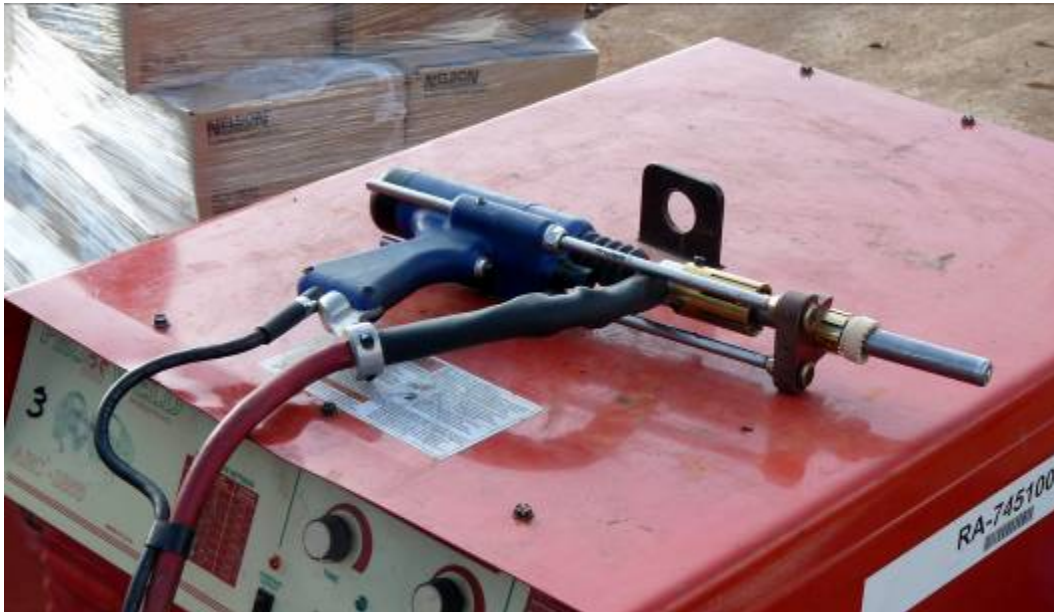
Figure 18. Shear stud welding head and gun with stud loaded.

Once the access holes were drilled, shear studs were welded to the girders using a specialized welder and gun system designed to perform in confined locations (Figure 18). The stud was loaded into the gun, placed into the desired location, and the weld completed when the trigger was pulled (Figure 19).

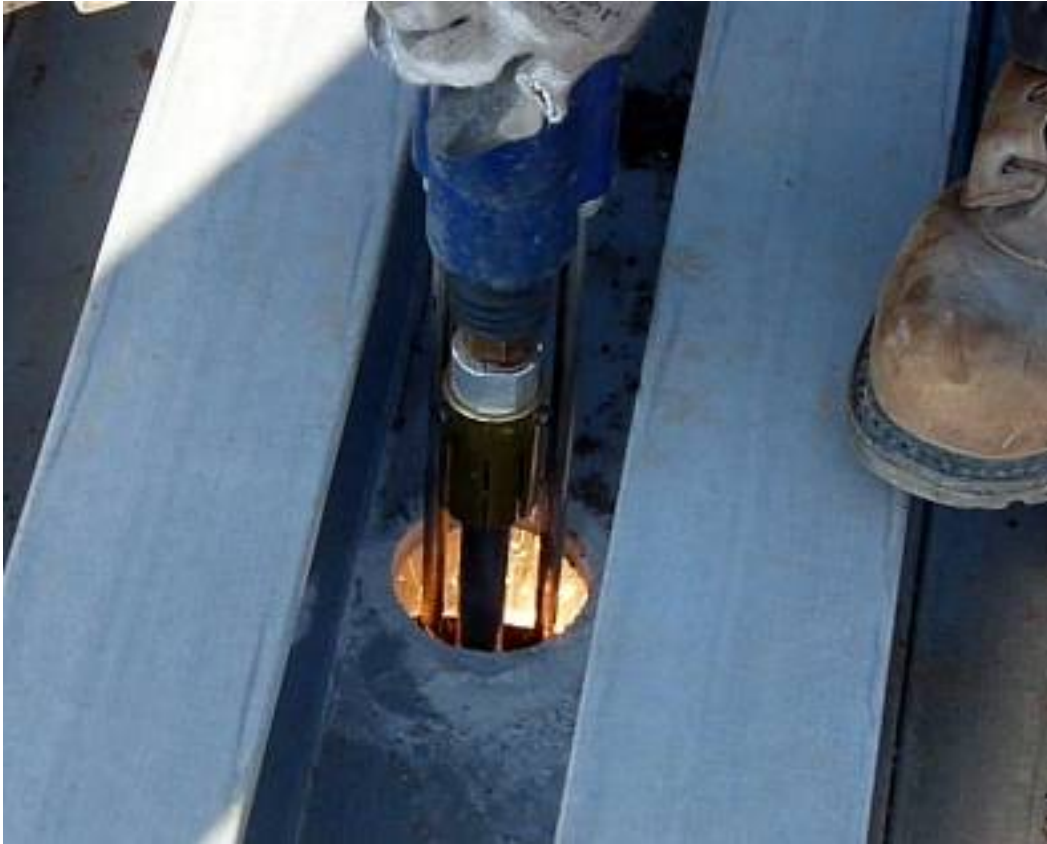
Figure 19. Welding a shear stud.

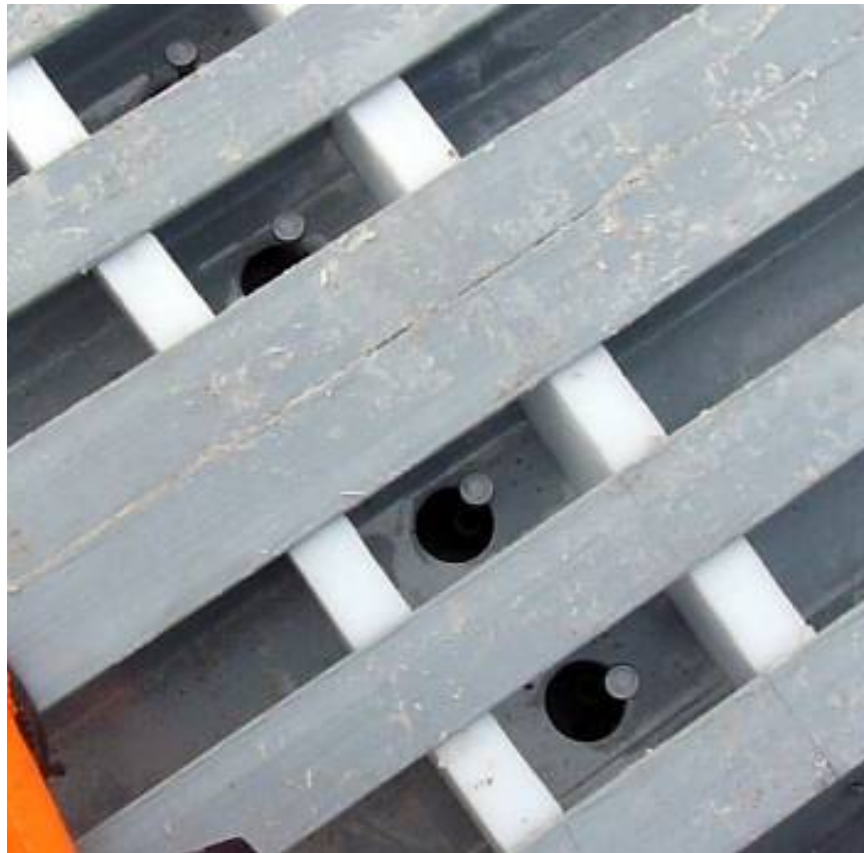
Figure 22. Foam grout dams in pultruded deck section.

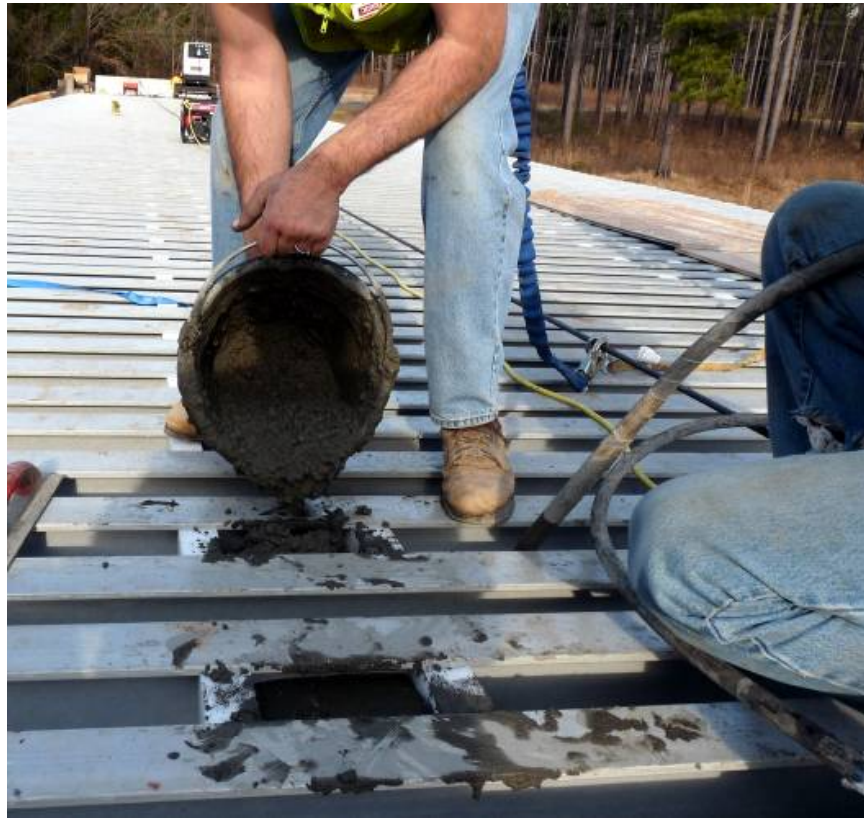
Figure 23. Hand-pouring grout into grout pockets.

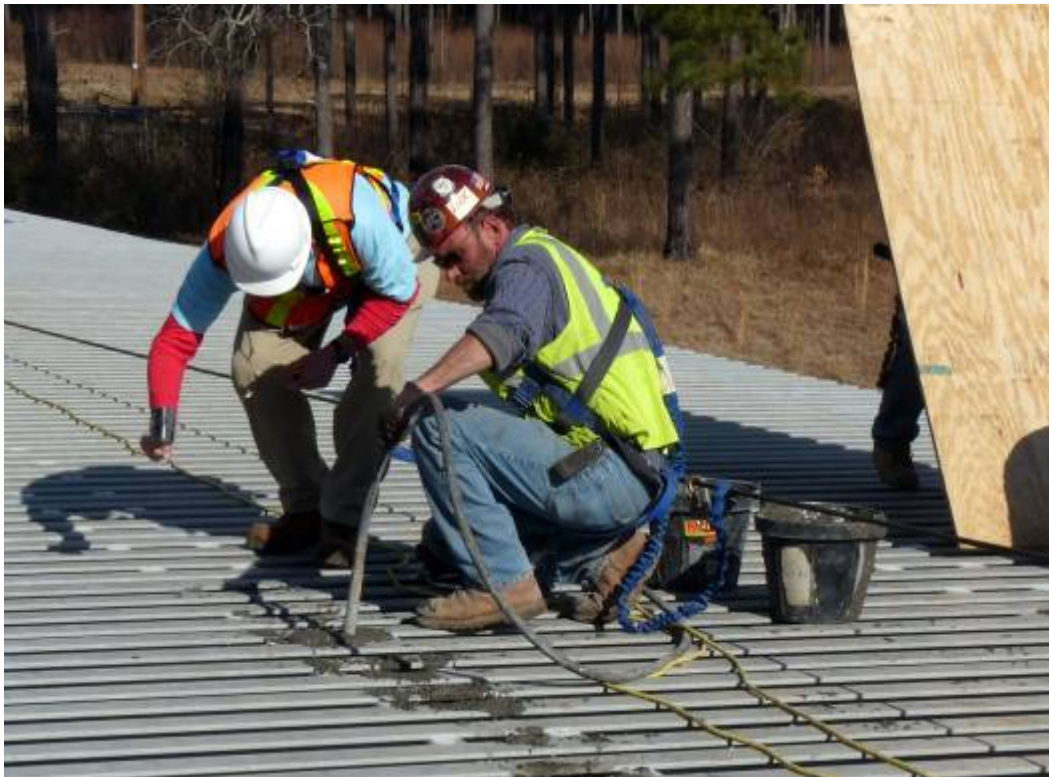
Figure 24. Vibrating fluid grout.

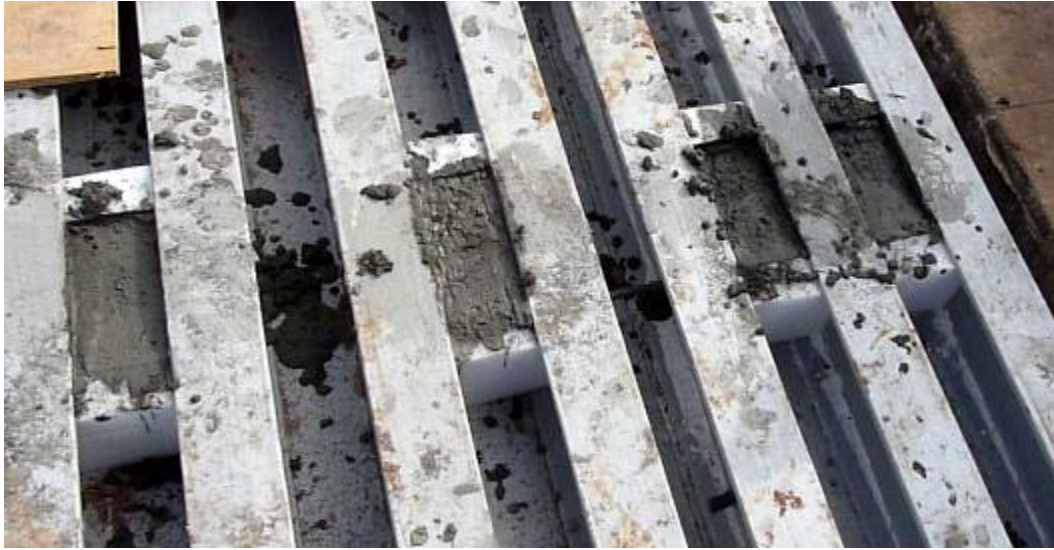
Figure 25. Filled grout pockets.

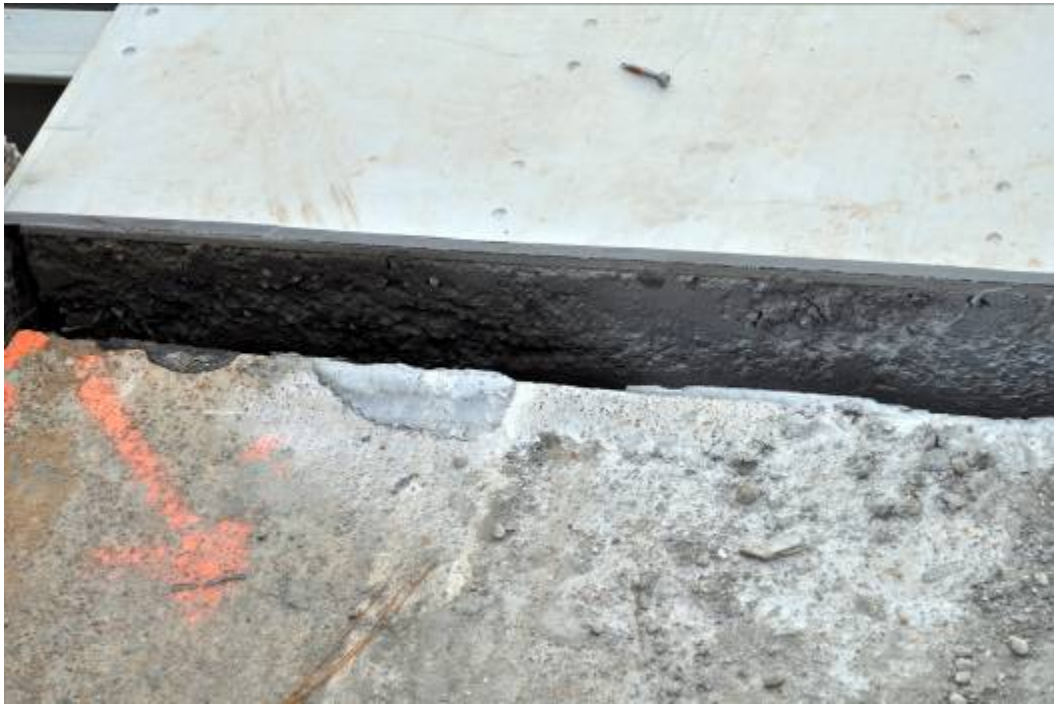
Figure 26. Concrete-filled bridge end showing sheet screwed to pultruded section.

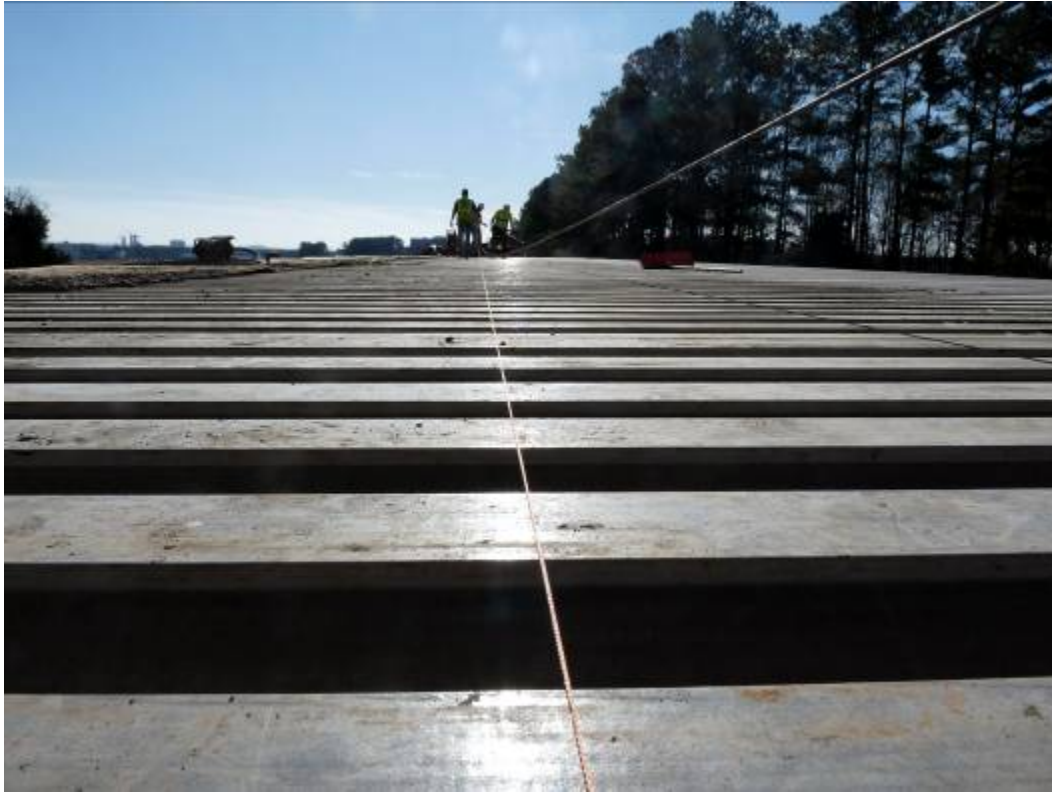
Figure 27. Bridge deck centerline.

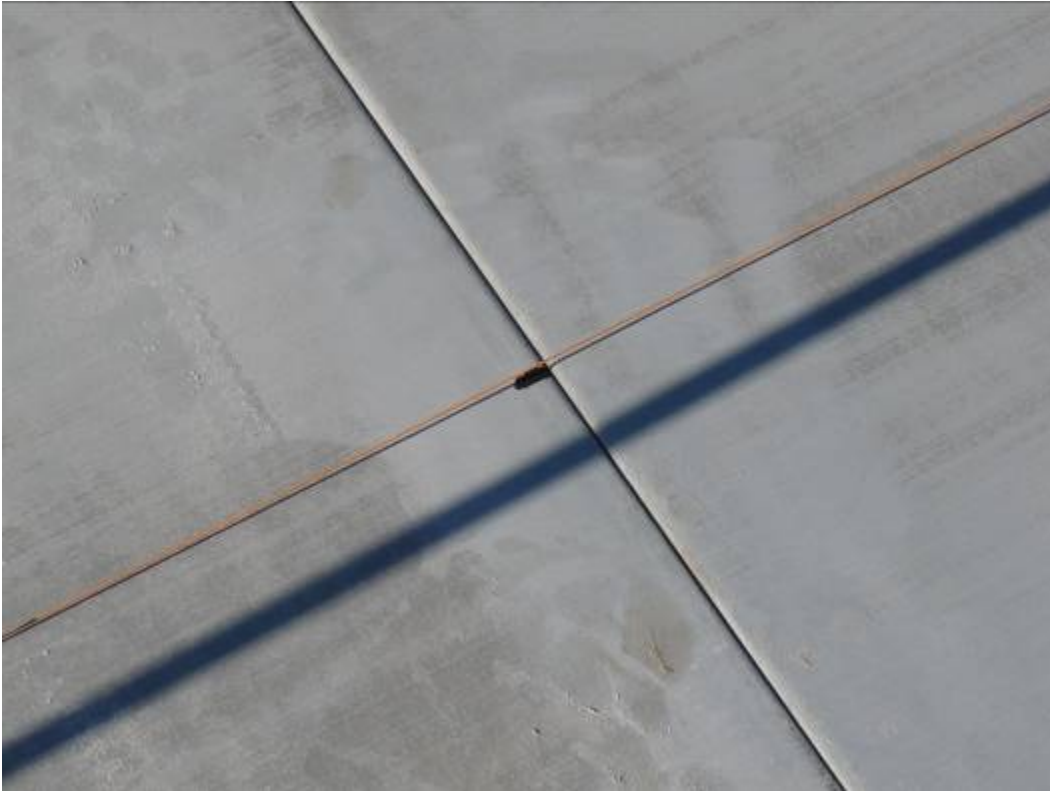
Figure 29. Centered GFRP composite top sheets.

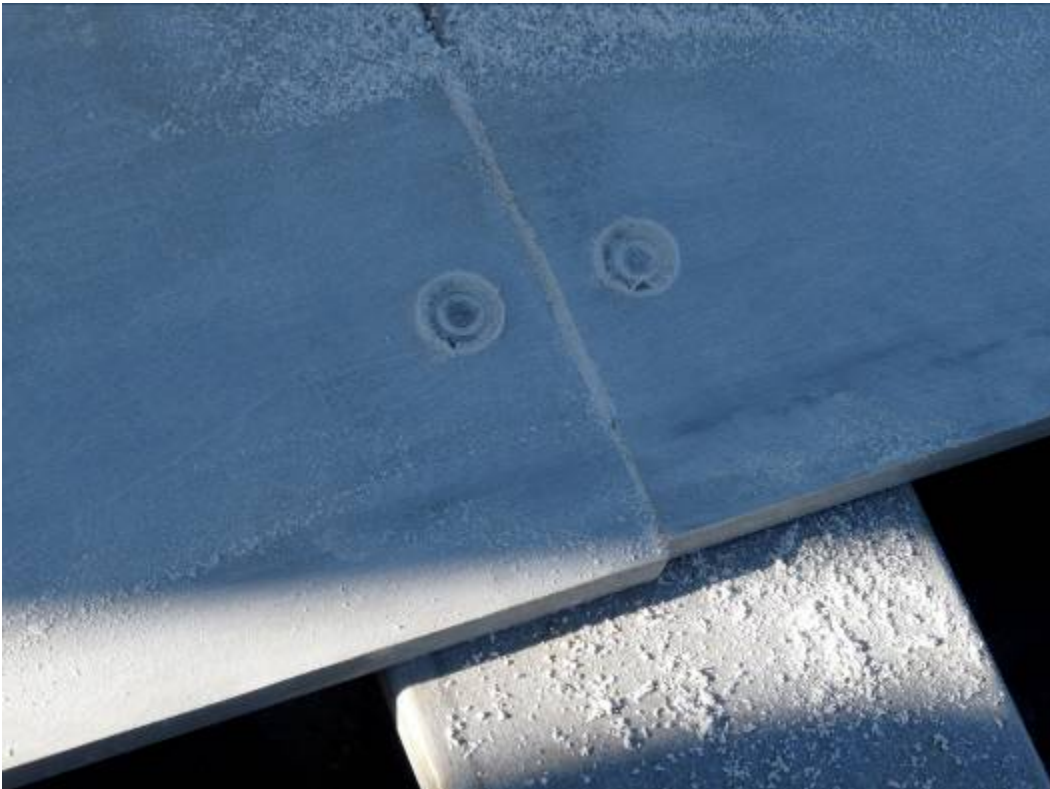
Figure 30. Holes drilled in GFRP composite top sheet before attachment with screws.

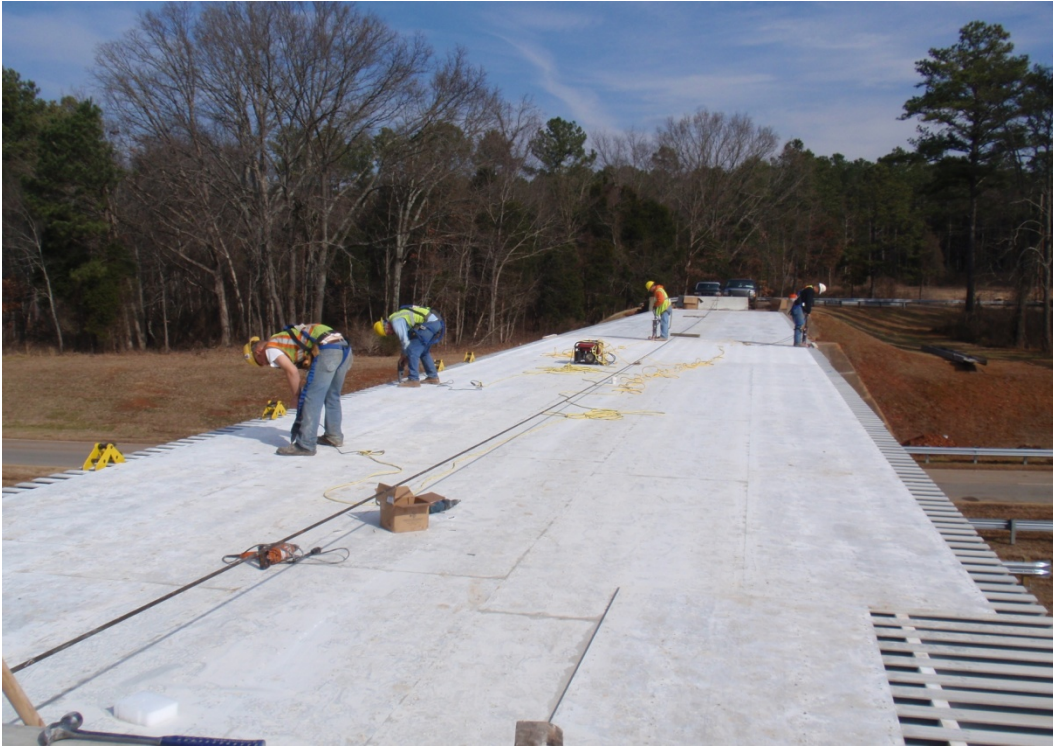
Figure 31. Installation of GFRP composite sheets.

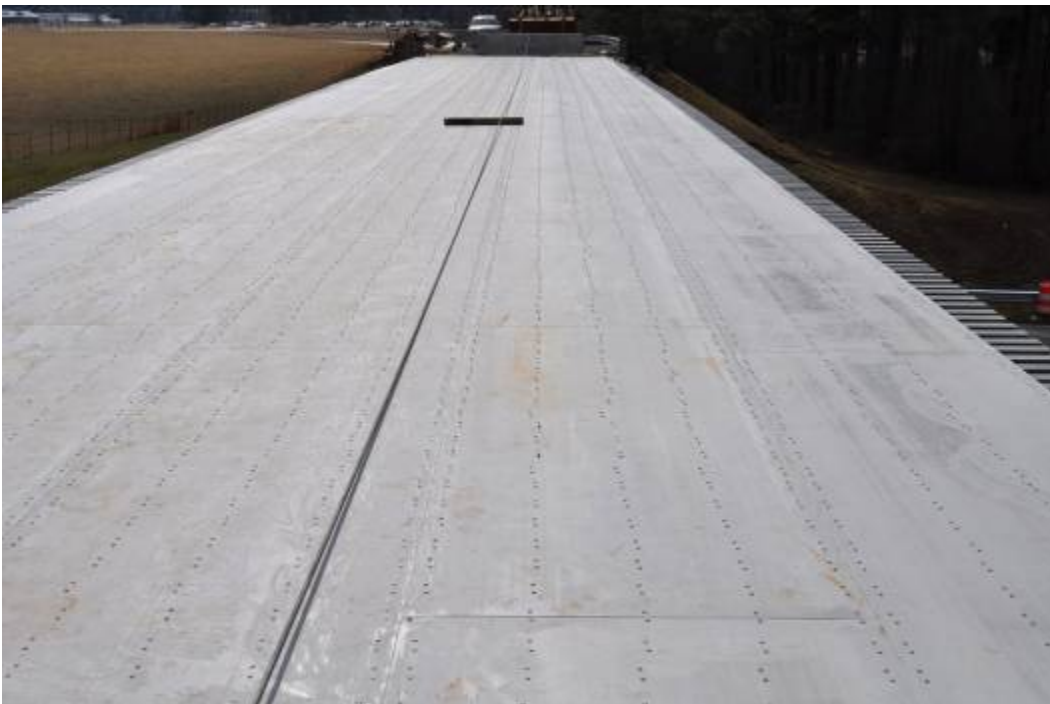
Figure 32. Installed GFRP composite top sheets.

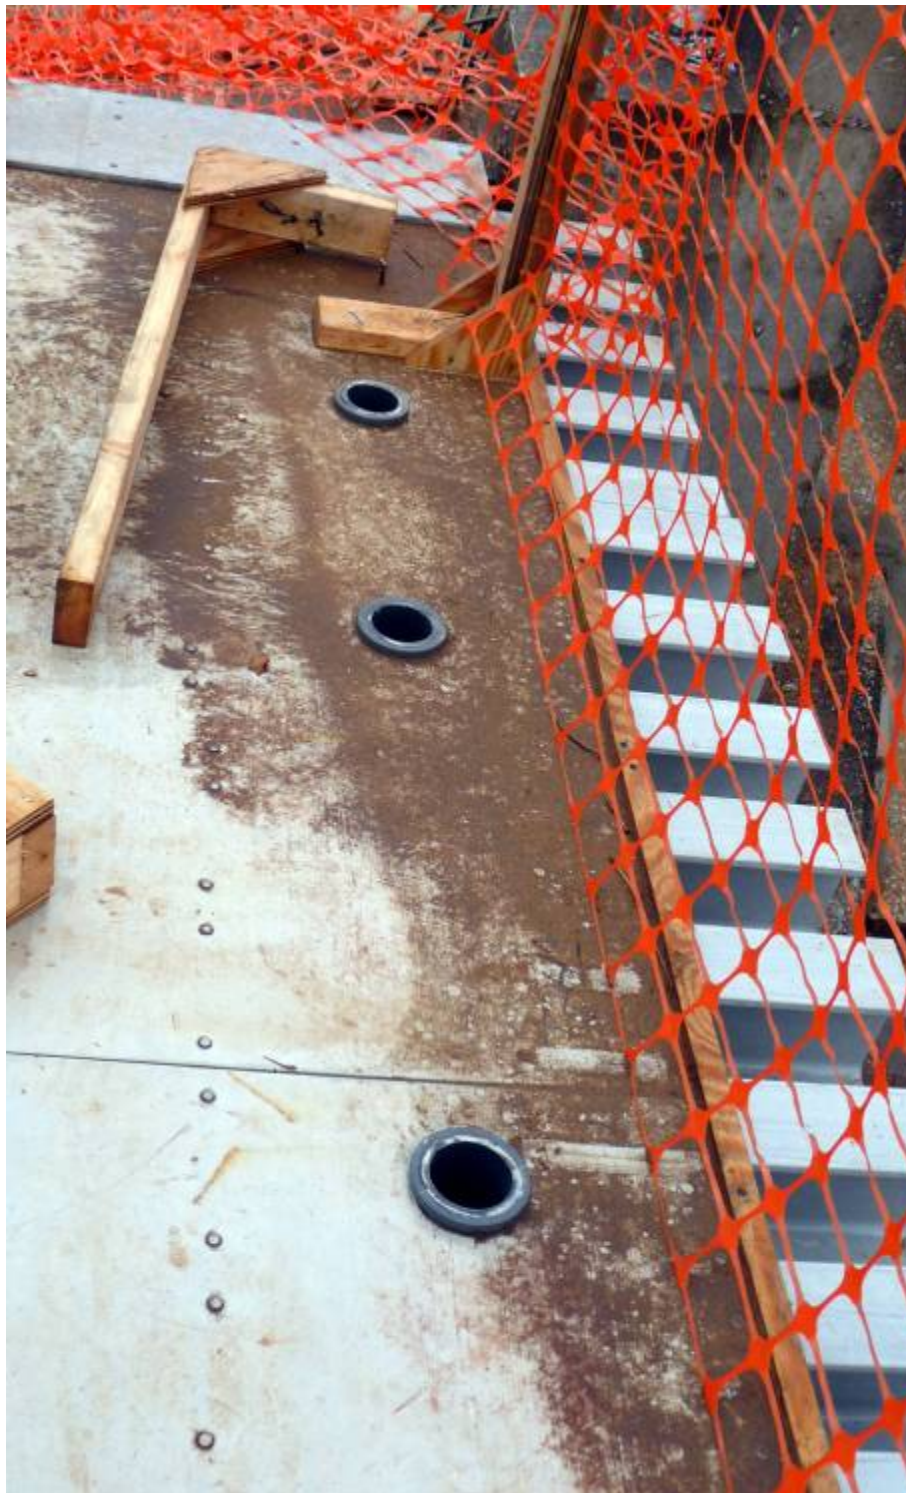
Figure 33. Scuppers installed in top sheet before barrier rail and wear surface installation.

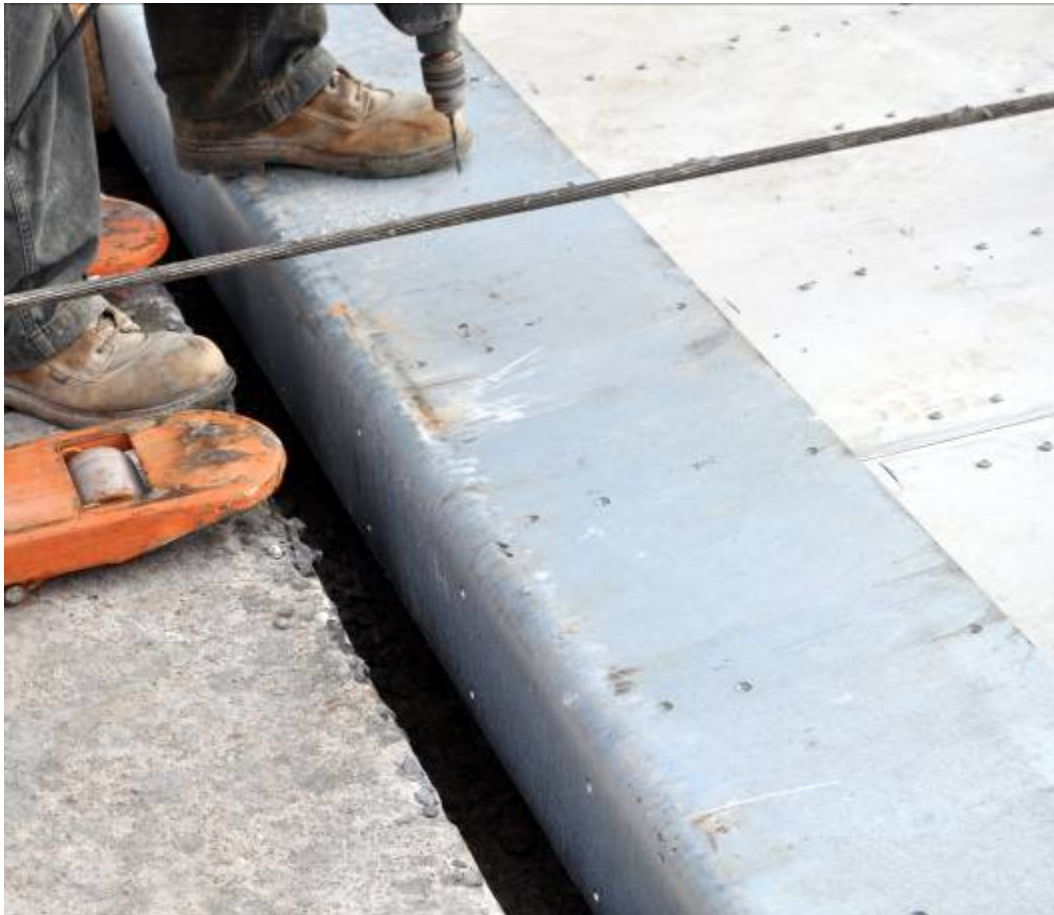
were installed to protect the composite deck components from vehicle wheel impacts. Installation of a plate is shown in Figure 34.

Figure 34. Installation of metal impact plate on end of deck.

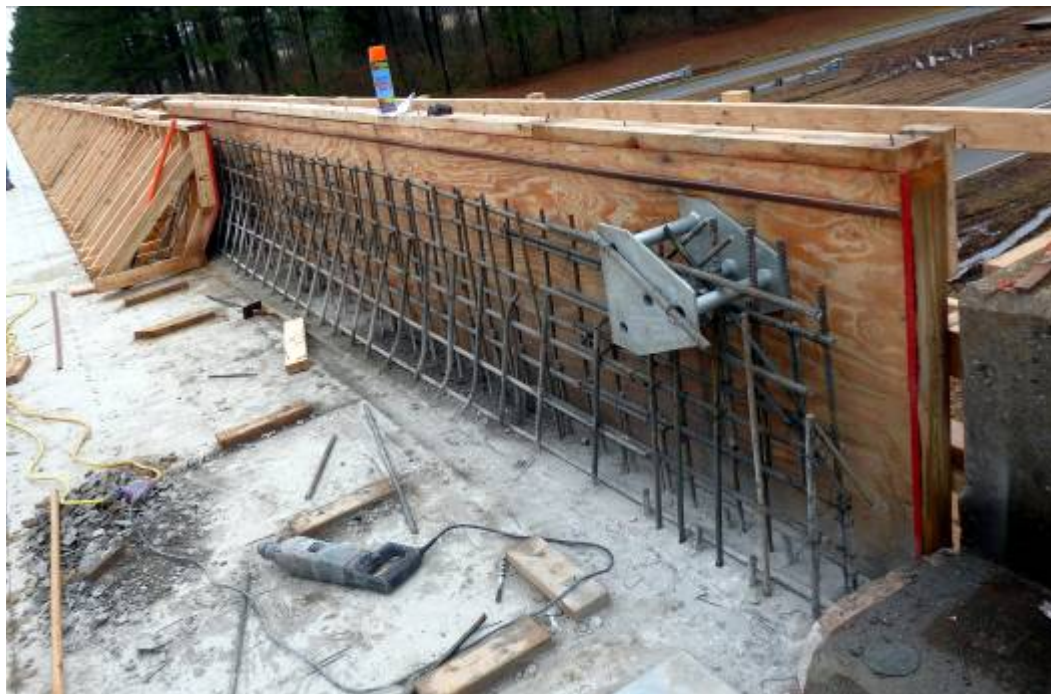
Figure 35. Barrier rail reinforcement steel in place.

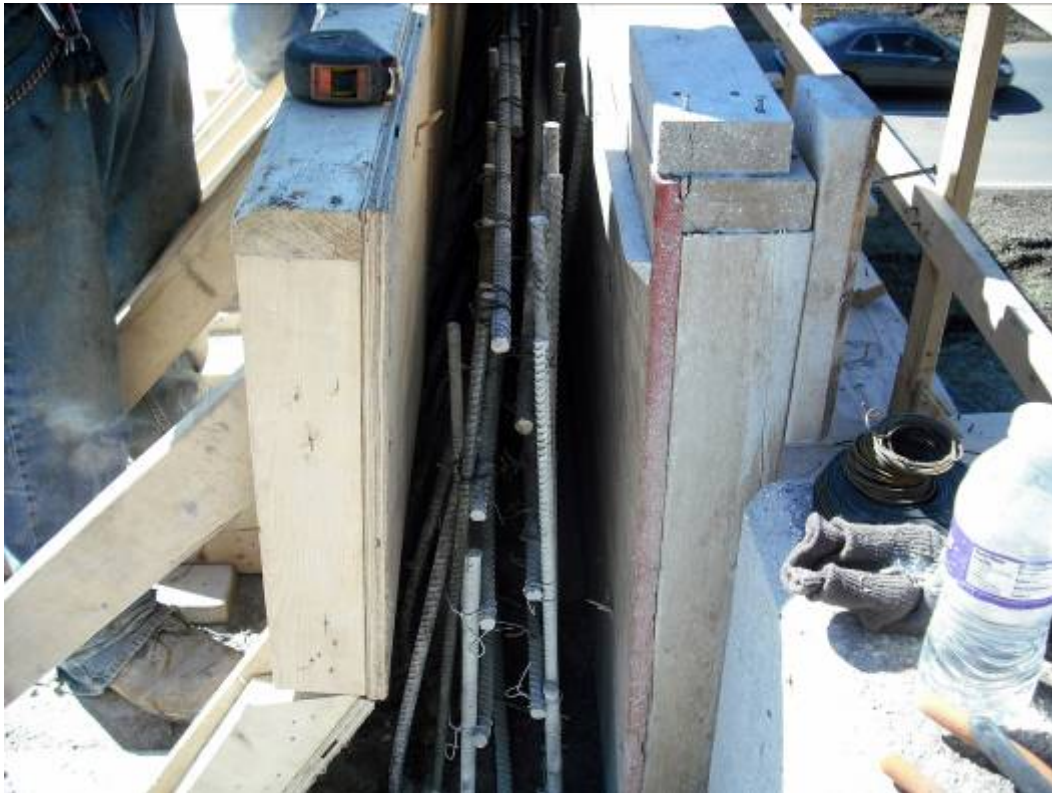
Figure 36. Barrier rail reinforcement and formwork.

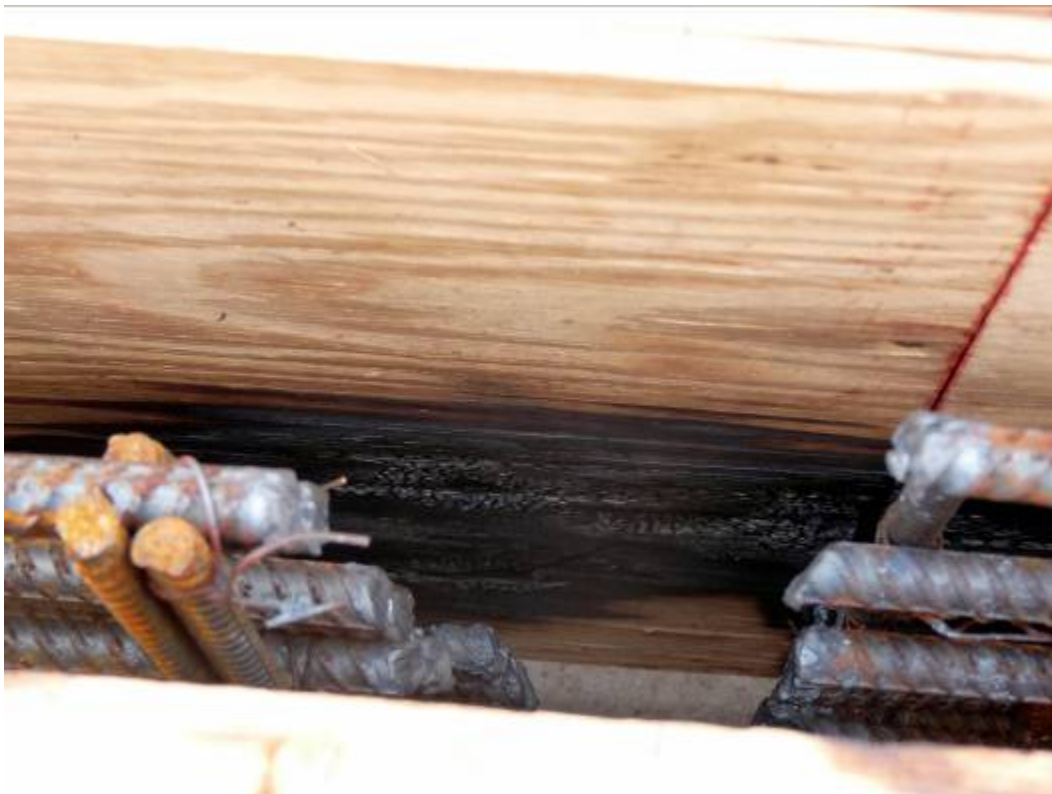
Figure 37. Cuts in barrier rail reinforcement steel for concrete expansion joint.

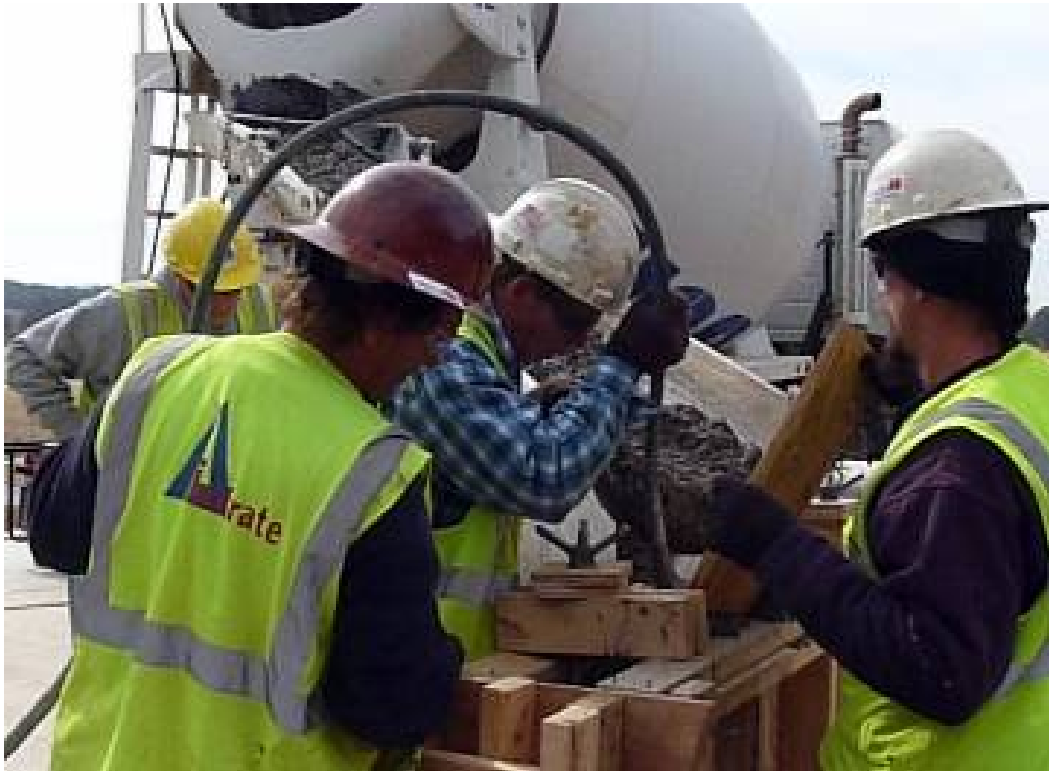
Figure 38. Barrier rail concrete pour into formwork.

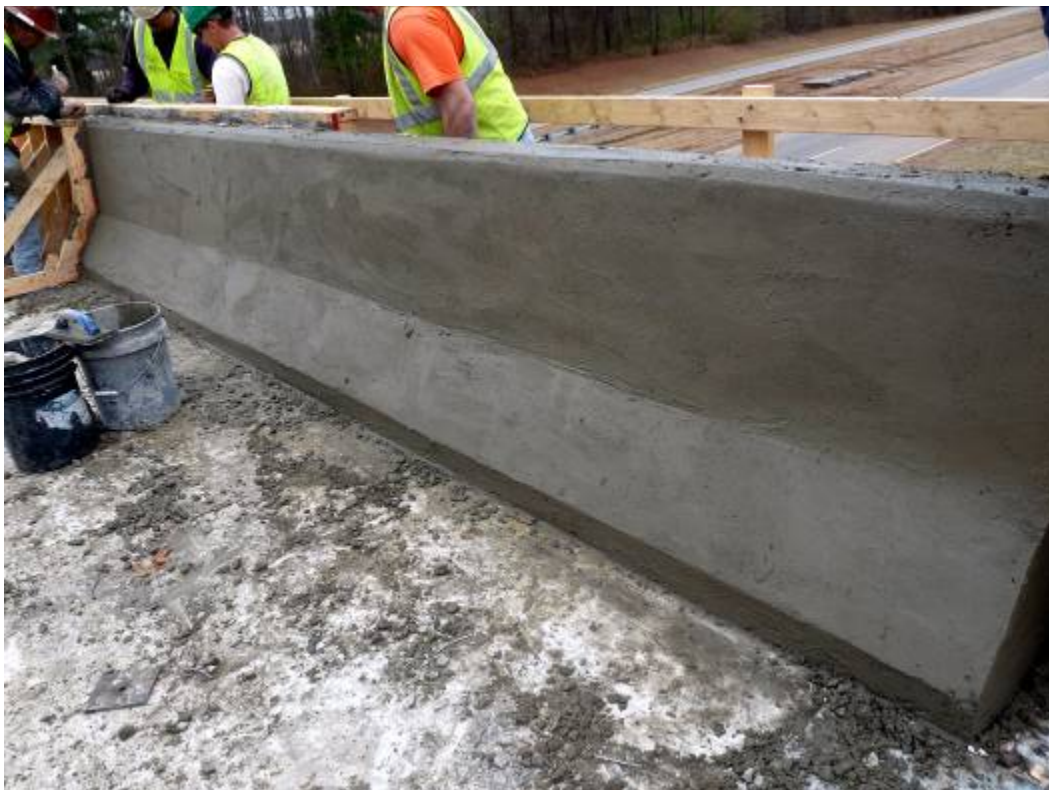
Figure 39. Finished barrier rail.

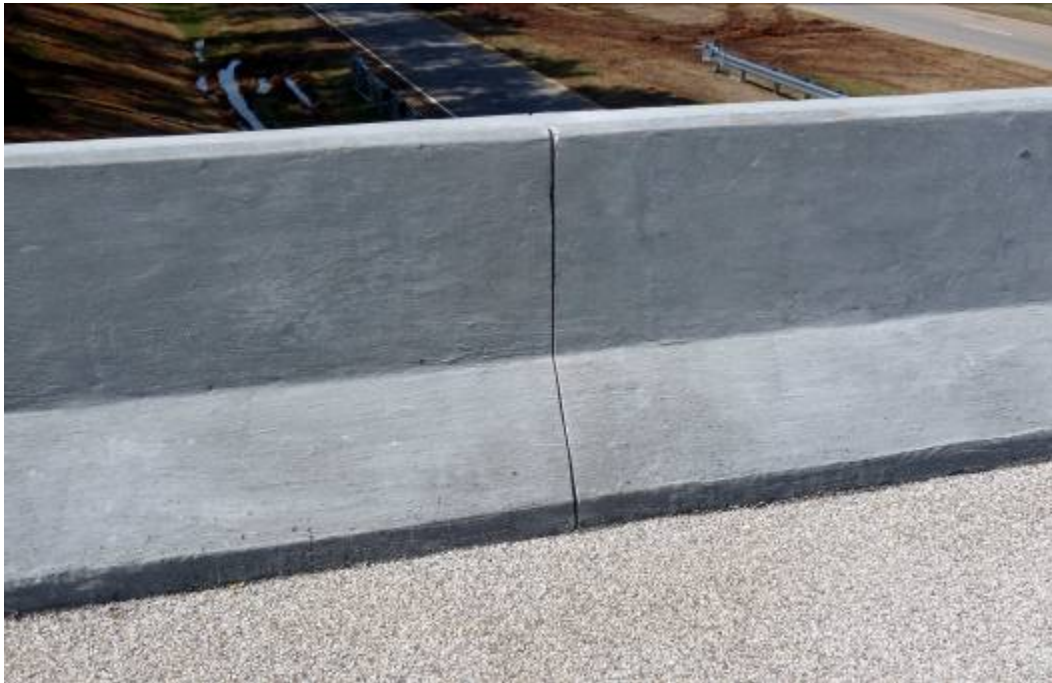
Figure 40. Cured barrier rail with saw-cut expansion joint.

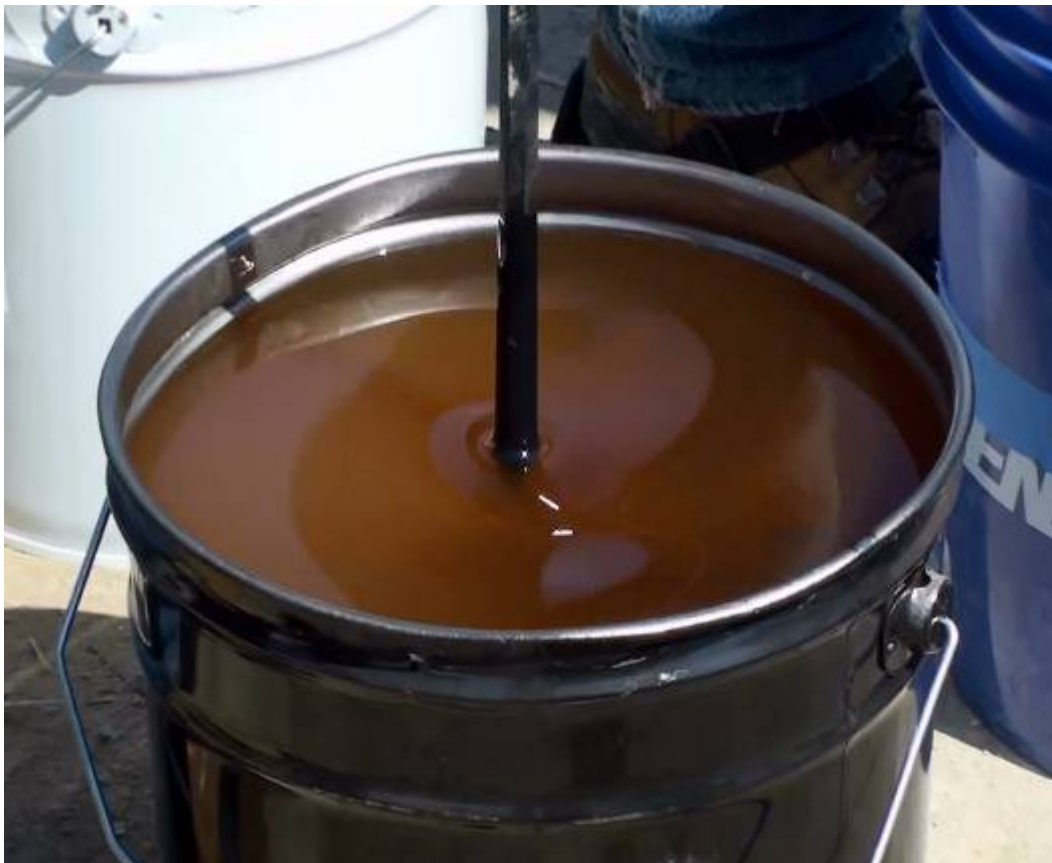
Figure 41. Mixing two-part polymer for wear surface.
